Flood Control Project Maintenance
2013 Structure Summary Report
Overall Unit and Item Ratings

Madera County FCWCA

Ash And Berenda Slough Control Structures

Flood Control Project Maintenance**Unit Cover Sheet****2013 Structure Inspection Results****Madera County FCWCA**

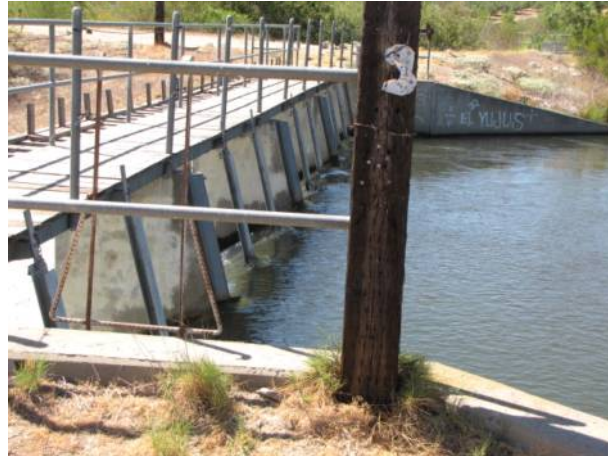
Levee Mile Report Line	1
Start Levee Mile	0.00
End Levee Mile	0.00
Location	
Category	Structures
Item	Photo Documentation
Berenda Slough Control Structure view of upstream side of structure. Photo taken 7-17-13.	
phillips_t_20130717_021.JPG

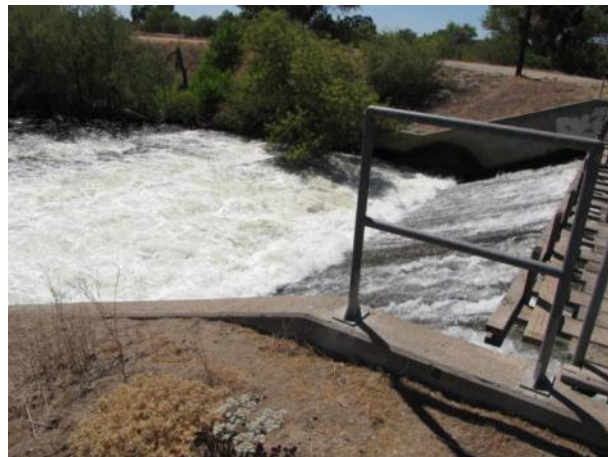
Levee Mile Report Line	1
Start Levee Mile	0.00
End Levee Mile	0.00
Location	
Category	Structures
Item	Photo Documentation
Berenda Slough Control Structure looking downstream. Photo taken 7-17-13.	
phillips_t_20130717_022.JPG

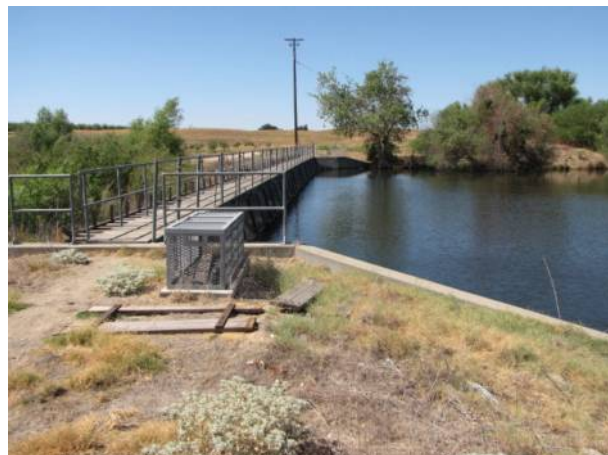
Levee Mile Report Line	1
Start Levee Mile	0.00
End Levee Mile	0.00
Location	
Category	Structures
Item	Photo Documentation
Ash Slough Diversion Structure from upstream side. Photo taken 7-17-13.	
phillips_t_20130717_023.JPG

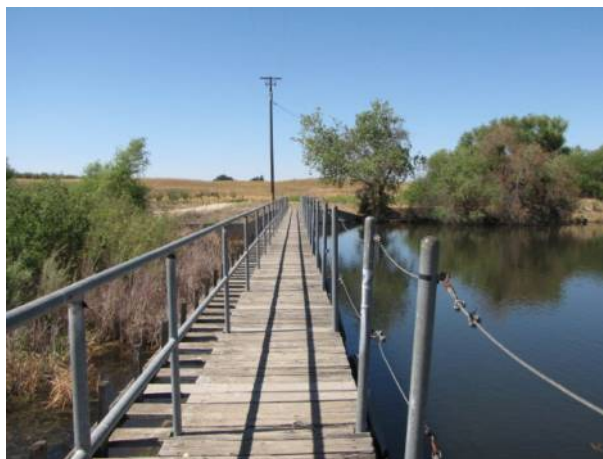
phillips_t_20130717_024.JPG

View of the structure. Photo taken 7-17-13.

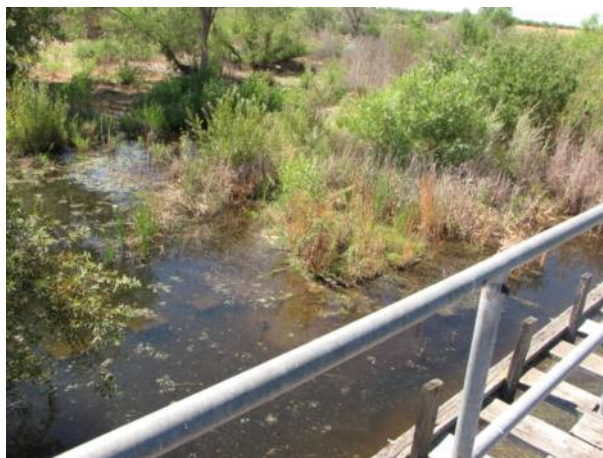
phillips_t_20130717_025.JPG

Ash Slough vegetation present at downstream of the structure. Photo taken 7-17-13.

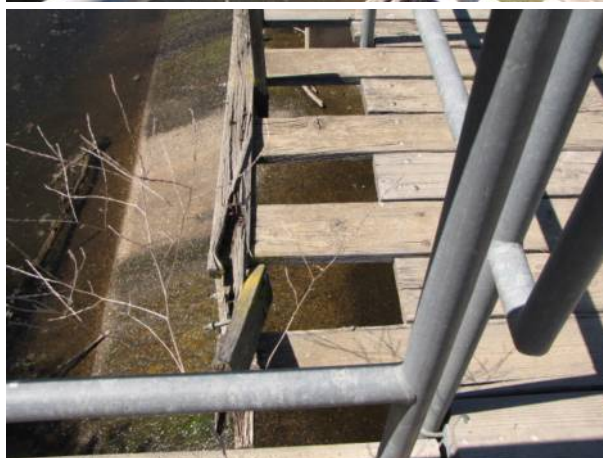
phillips_t_20130717_026.JPG

LMR No.	Levee Mile		Category	Item	Location *	Rating **	Action/Comment	GPS Latitude/Longitude		Issue No.
	Start	End						Start	End	Photo
23	0.00	0.00	Structures	Safety		M	Inspector Comments: Minor safety hazards are present, but do not pose an immediate threat to the structure or personnel at the structure. Corrections should be made prior to the next annual inspection. The damages reported in the last inspection hasn't been corrected to date.	37.157904 ° -120.124165 °	37.143520 ° -120.162171 °	23 Y
24	0.00	0.00	Structures	Operation & Maintenance Manual		A	Inspector Comments: The manual is on file in the office.	37.157904 ° -120.124165 °	37.143520 ° -120.162171 °	24

Damaged timber on downstream side of Ash Slough Structure has not been replaced. Photo taken 7-17-13.

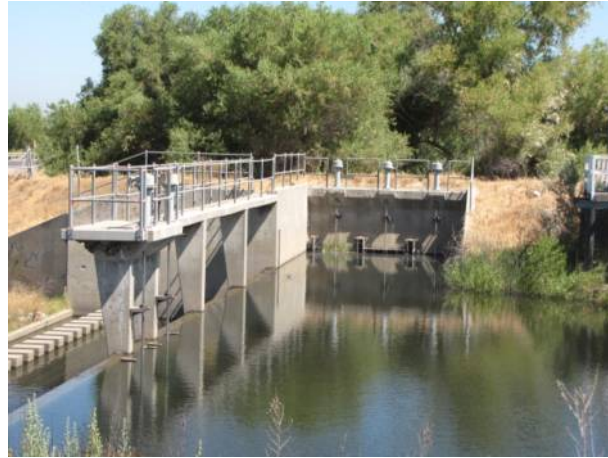
Levee Mile Report Line	1
Start Levee Mile	0.00
End Levee Mile	0.00
Location	
Category	Structures
Item	Photo Documentation
Fresno River Diversion Weir viewed from left bank. Photo taken 7-17-13.	
phillips_t_20130717_017.JPG

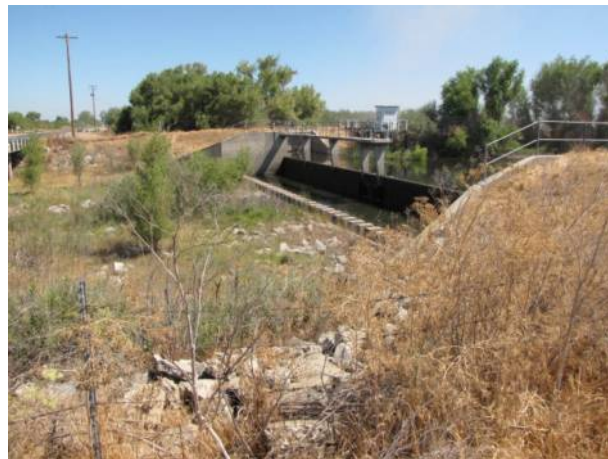
LMR No.	Levee Mile		Category	Item	Location	Rating	Action/Comment	GPS Latitude/Longitude		Issue No.
	Start	End						Start	End	Photo
1	0.00	0.00	Structures	Photo Documentation		N		36.967930 ° -120.255680 °	36.967930 ° -120.255680 °	1 Y
2	0.00	0.00	Structures	Vegetation & Obstructions		M	Inspector Comments: There is a build up of vegetation on the downstream side of the deflectors within the channel of the Fresno River and on the left bank (unit 6) there is buildup of veg. growth inside the security fence area on the bank.	36.967930 ° -120.255680 °	36.967930 ° -120.255680 °	2 Y
3	0.00	0.00	Structures	Shoaling / Sedimentation		A	Inspector Comments: No shoaling or sedimentation present.	36.967930 ° -120.255680 °	36.967930 ° -120.255680 °	3
4	0.00	0.00	Structures	Erosion / Bank Caving		A	Inspector Comments: There was no presence of erosion at this structure during my inspection 7-12-2011	36.967930 ° -120.255680 °	36.967930 ° -120.255680 °	4

Levee Mile Report Line	2
Start Levee Mile	0.00
End Levee Mile	0.00
Location	
Category	Structures
Item	Vegetation & Obstructions
This photo taken from left bank shows where vegetation is present downstream of the weir. Photo taken 7-17-13.	
phillips_t_20130717_018.JPG

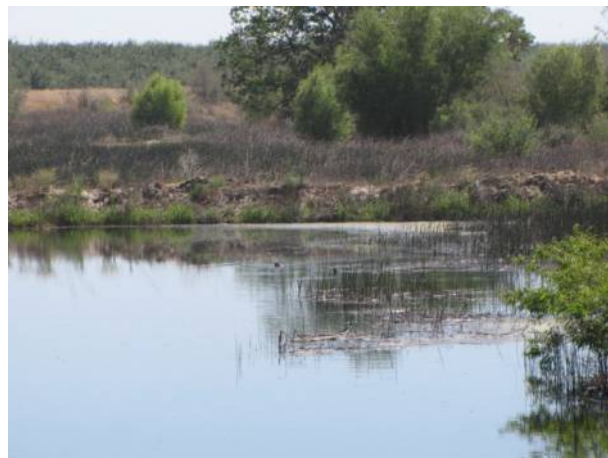
Levee Mile Report Line	6
Start Levee Mile	0.00
End Levee Mile	0.00
Location	
Category	Structures
Item	Encroachments
This earthen dam has no CVFPB permit. Photo taken 7-17-13.	
phillips_t_20130717_019.JPG

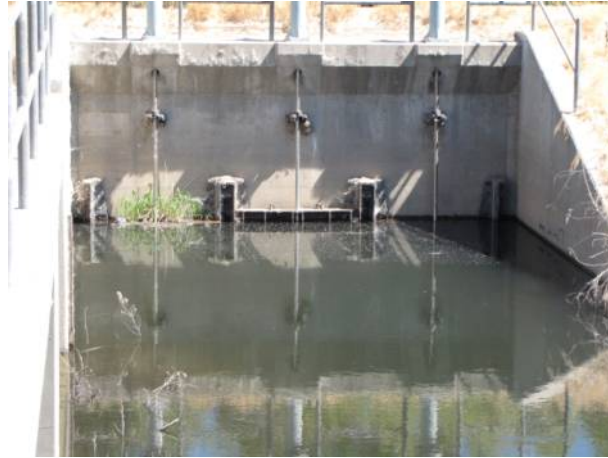
Levee Mile Report Line	11
Start Levee Mile	0.00
End Levee Mile	0.00
Location	
Category	Structures
Item	Flap Gates
This structure has screw gates, that were closed during this inspection. Photo taken 7-17-13.	
phillips_t_20130717_020.JPG
